Re: Notice of Violation  
Scott Plating, Inc.  
EPA ID No.: ILD056629629

COMPLIANCE EVALUATION INSPECTION REPORT

INSTALLATION NAME: Scott Plating, Incorporated

DATE OF INSPECTION: August 15, 2012

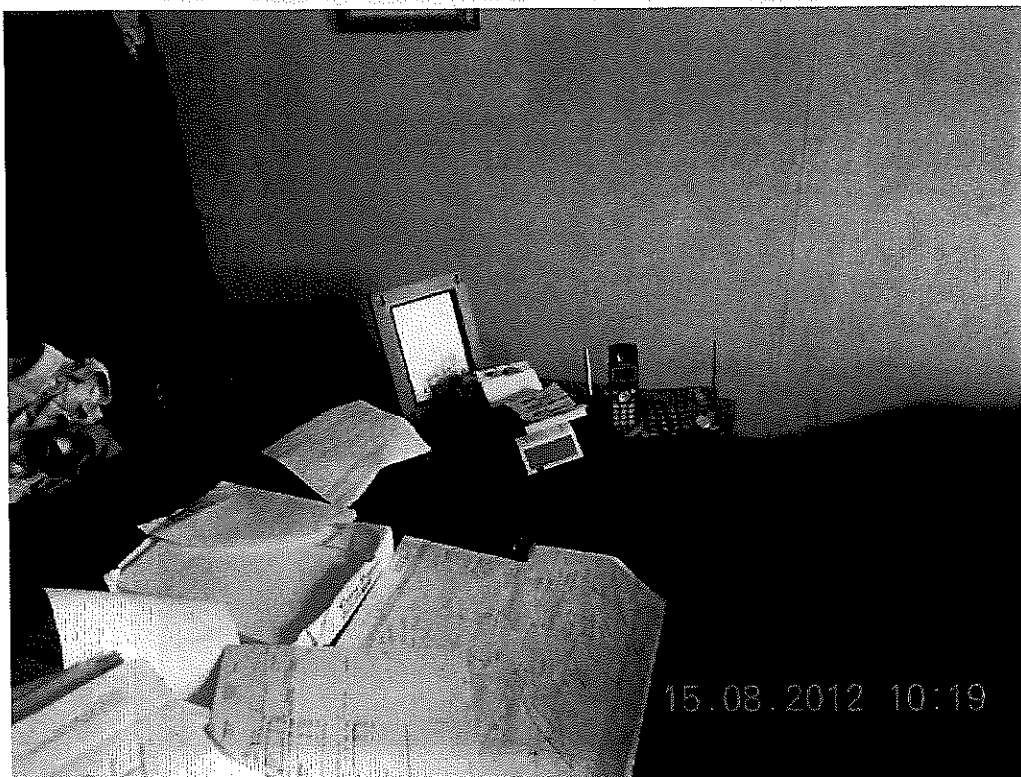
<b>Facility:</b> Scott Plating, ILD056629629
<b>Location:</b> 8034 North Central Park Avenue, Skokie, Illinois
<b>Date:</b> August 15, 2012
<b>Photographer:</b> Robert Dean Smith, LPG
<b>Camera:</b> Nikon Coolpix, 12.0 megapixels
<b>Description:</b> <b>Photograph 1:</b> Office on the second floor of the Scott Plating facility. I was not able to find a list of emergency contacts at or near the telephone in this photograph. I did not check the rolodex.

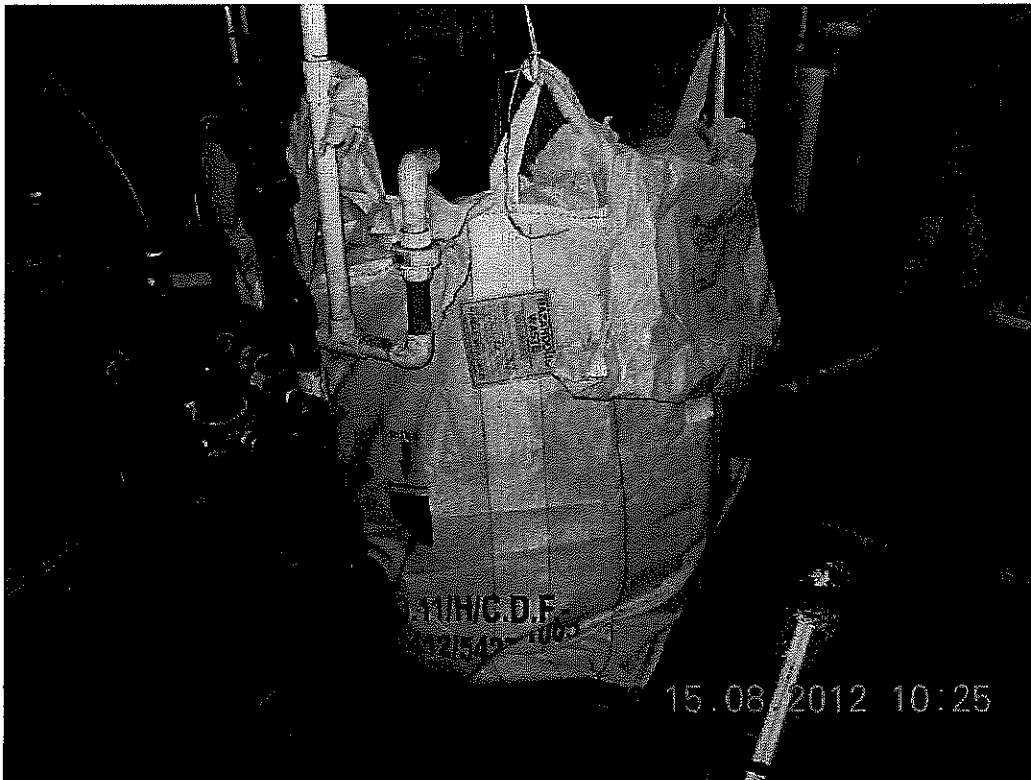
<b>Facility:</b> Scott Plating, ILD056629629
<b>Location:</b> 8034 North Central Park Avenue, Skokie, Illinois
<b>Date:</b> August 15, 2012
<b>Photographer:</b> Robert Dean Smith, LPG
<b>Camera:</b> Nikon Coolpix, 12.0 megapixels
<b>Description:</b> <b>Photograph 2:</b> Supersack under the filter press. The supersack has a hazardous waste label.

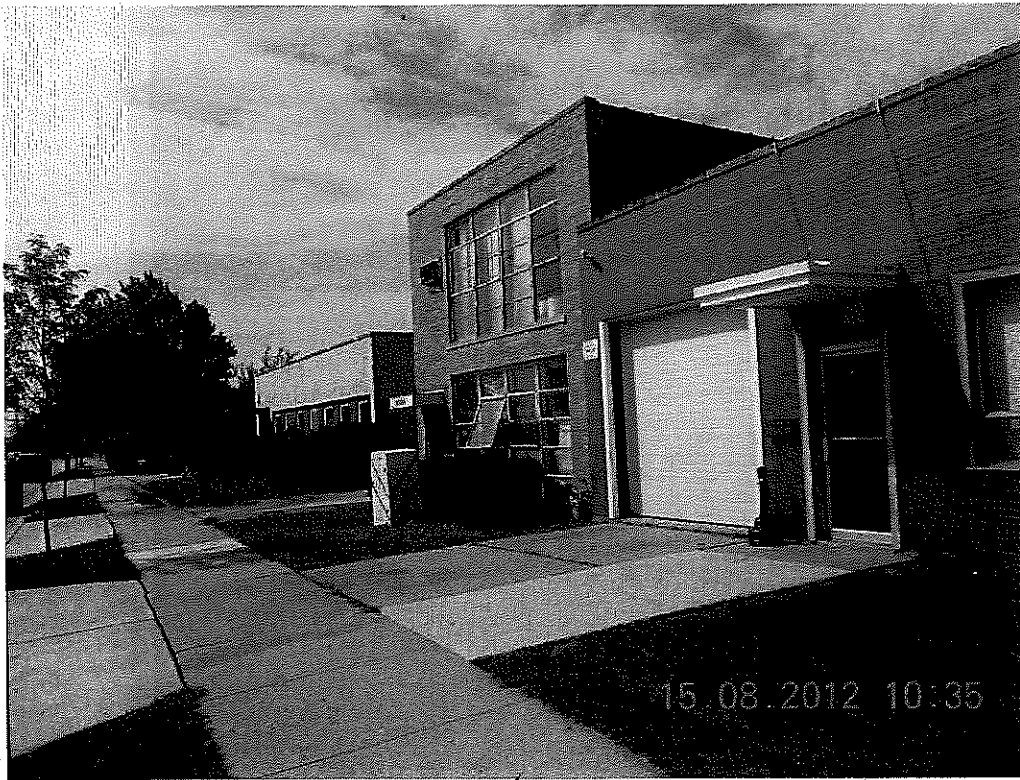
<b>Facility:</b> Scott Plating, ILD056629629
<b>Location:</b> 8034 North Central Park Avenue, Skokie, Illinois
<b>Date:</b> August 15, 2012
<b>Photographer:</b> Robert Dean Smith, LPG
<b>Camera:</b> Nikon Coolpix, 12.0 megapixels
<b>Description:</b> Photograph 3: Outside of Scott Plating. Scott is the brown brick building with many windows.

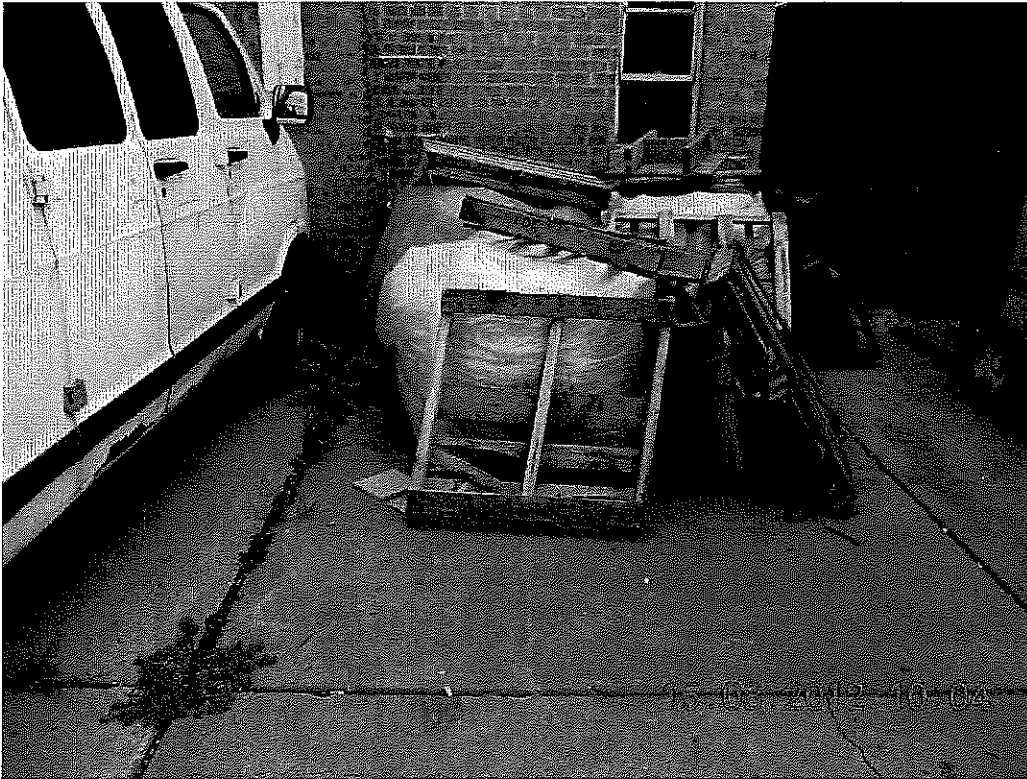
**Description: Photograph 4.** Rear of the Scott Plating building. Scott is storing three supersacks of F006 hazardous waste outside its facility within the confines of the stacked pallets seen here. The supersacks are covered by either clear or blue visqueen. The hazardous waste labels are affixed to the supersacks; however, the ink has either run or cannot be read through the visqueen.

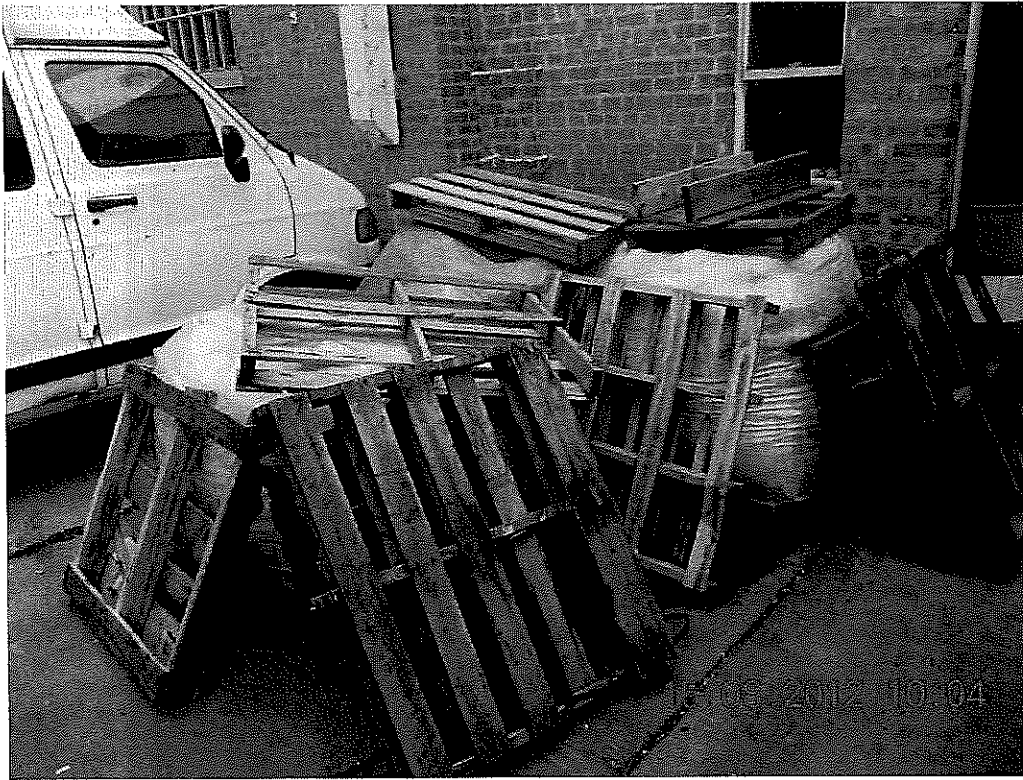
<b>Facility:</b> Scott Plating, ILD056629629
<b>Location:</b> 8034 North Central Park Avenue, Skokie, Illinois
<b>Date:</b> August 15, 2012
<b>Photographer:</b> Robert Dean Smith, LPG
<b>Camera:</b> Nikon Coolpix, 12.0 megapixels
<b>Description:</b> Photograph 4; Close up of the three hazardous waste supersacks in storage behind the Scott Plating facility.

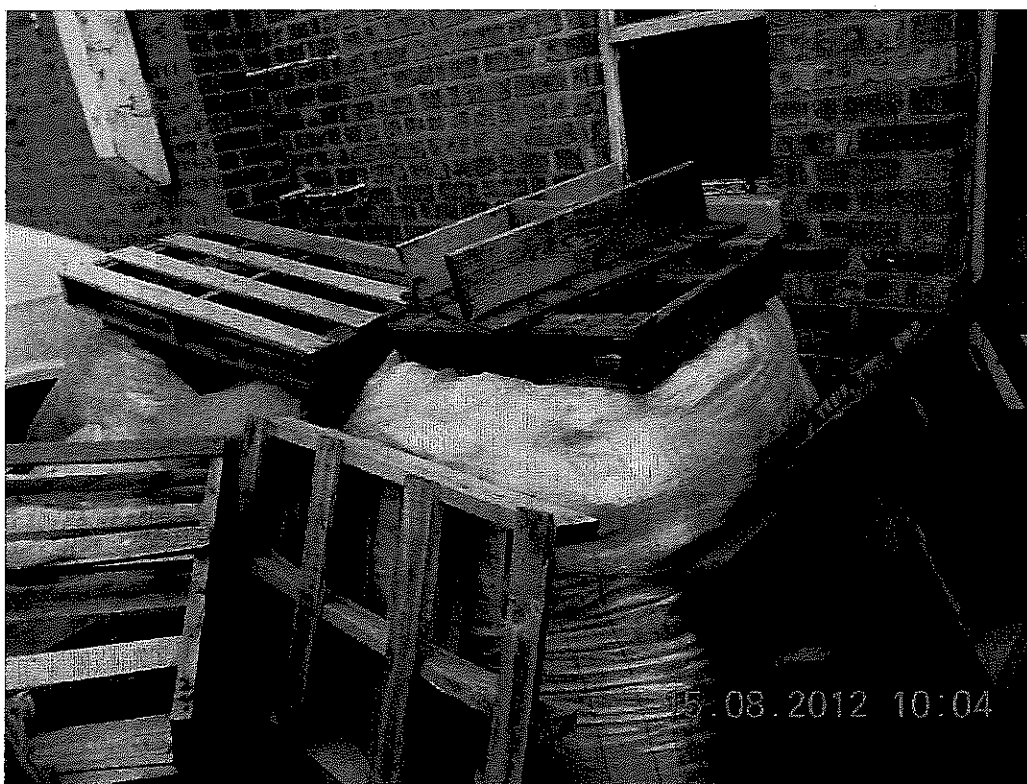
<b>Facility:</b> Scott Plating, ILD056629629
<b>Location:</b> 8034 North Central Park Avenue, Skokie, Illinois
<b>Date:</b> August 15, 2012
<b>Photographer:</b> Robert Dean Smith, LPG
<b>Camera:</b> Nikon Coolpix, 12.0 megapixels
<b>Description: Photograph 5:</b> Close up of the supersacks containing F006 hazardous waste in storage outside and in the rear of the Scott building.

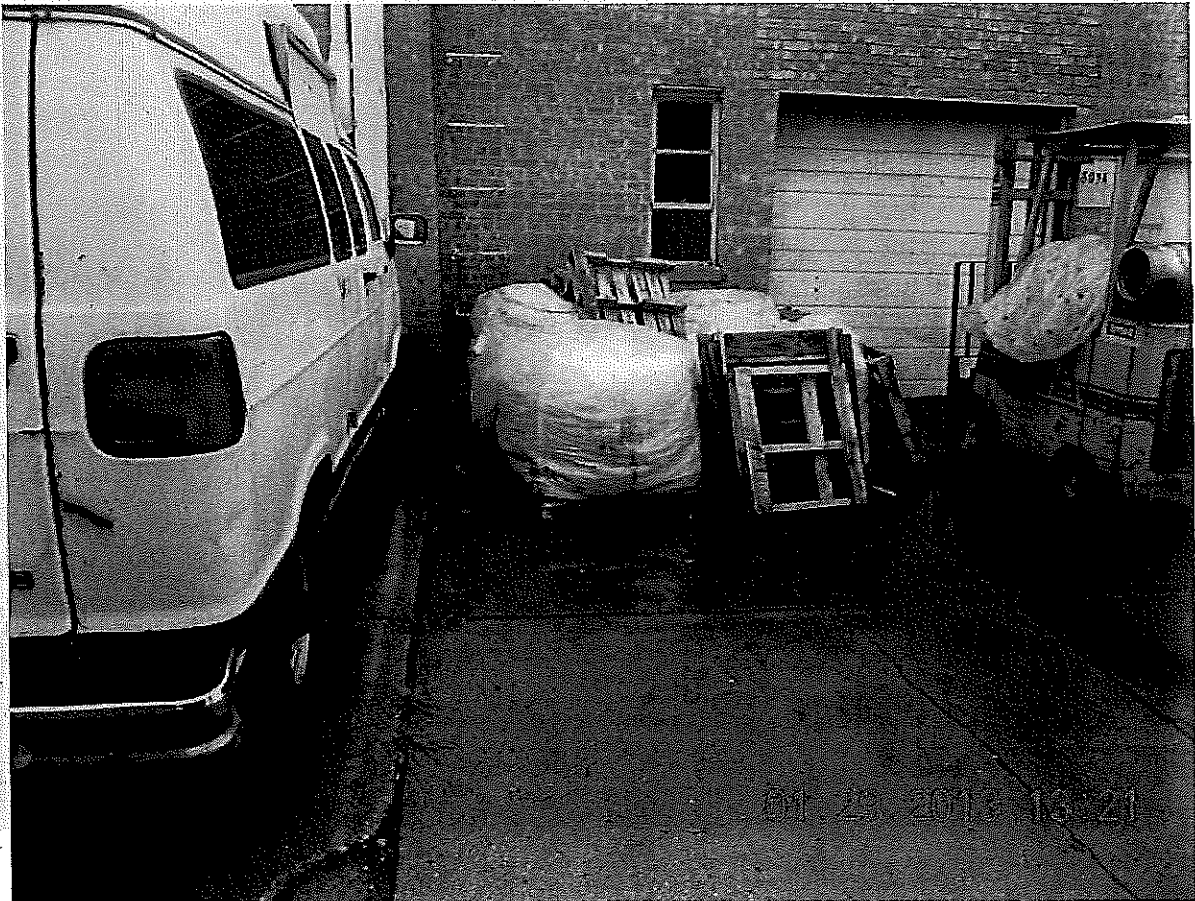
**Location:** Public Alleyway, behind the facility.

**Photograph 1:** Four supersacks of hazardous waste in storage behind the facility. The supersacks are covered with visqueen and it is difficult to see or read hazardous waste stickers.

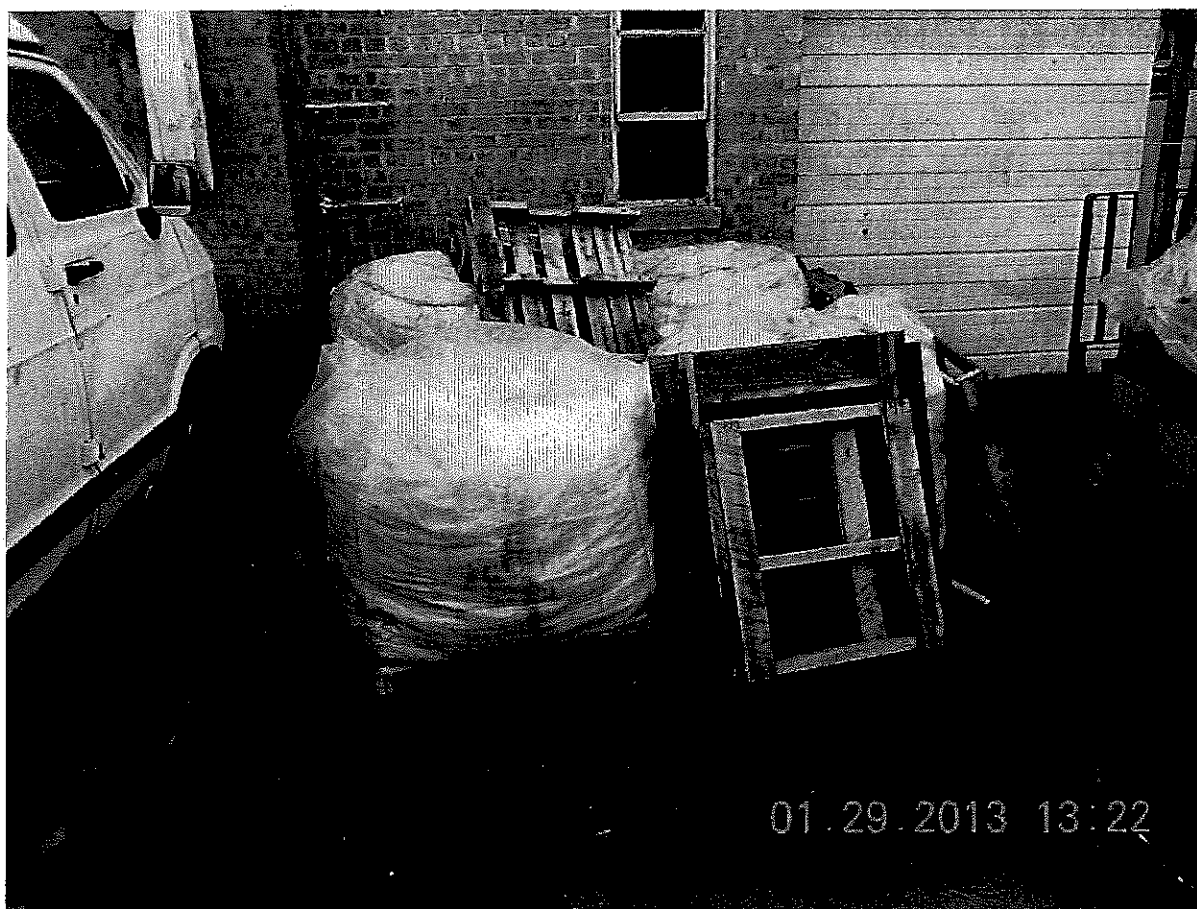
**Location:** Public Alleyway, behind the facility.

**Photograph 2:** Four supersacks of hazardous waste in storage behind the facility. The supersacks are covered with visqueen and it is difficult to see or read hazardous waste stickers. Close up of photograph 1.
